## Large-scale digital mapping of the Philippine fault zone based on aerial photograph interpretation:

### Philippine fault zone maps:

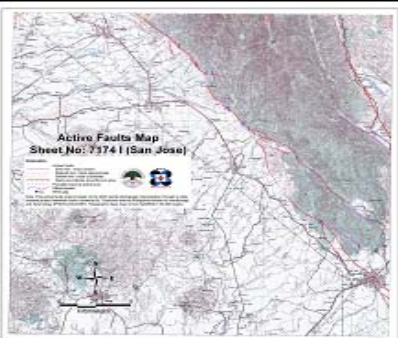
Figure 2: Active faults map of San Jose City, Nueva Ecija.

At present, approximately **90% of on-land-stretch of the PFZ** has been mapped. This delineation is based on interpretation of available large-scale (at least 1:30,000) aerial photographs. In areas where there are no available aerial photographs, various satellite images are used to map the fault zone. The identified surface traces of the PFZ are then plotted onto 1:50,000 topographic maps published by NAMRIA and compiled using commonly used Geographic Information System (GIS) platforms such as MapInfo Professional and Generic Mapping Tool (GMT). These active faults maps are now available on this website and upon request to PHIVOLCS-DOST (Figure 2: example of active faults map).
