Large-scale digital mapping of the Philippine fault zone based on aerial photograph interpretation:

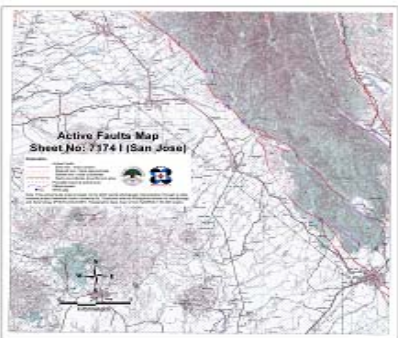
Figure 2: Active faults map of San Jose City, Nueva Ecija.

At present, approximately **90% of on-land-stretch of the PFZ** has been mapped. This delineation is based on interpretation of available large-scale (at least 1:30,000) aerial photographs. In areas where there are no available aerial photographs, various satellite images are used to map the fault zone. The identified surface traces of the PFZ are then plotted onto 1:50,000 topographic maps published by NAMRIA and compiled using commonly used Geographic Information System (GIS) platforms such as MapInfo Professional and Generic Mapping Tool (GMT). These active faults maps are now available on this website and upon request to PHIVOLCS-DOST (Figure 2: example of active faults map).
